SCIENTIFIC INVESTIGATION REPORT

Jacob Sean Barben v. Federal Cartridge Company et al.

Ct. Case No.: 1:16-CV-00094-DN
Rep./Ins.: Federal Cartridge Company
Loss Location: Bear River Pheasant Hunting Grounds, Elwood, Utah
Date of Loss: October 30, 2014
AEI Project No.: 13131

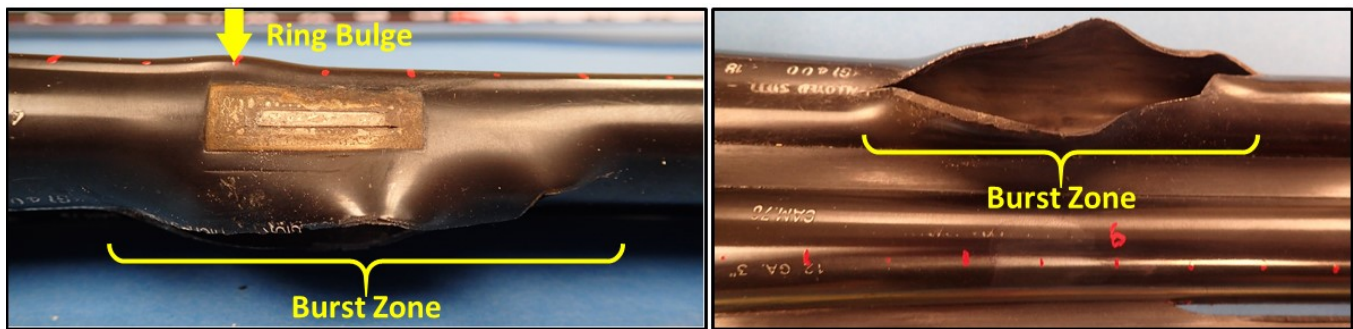
Figure 2 shows photos of the apparent lower barrel burst zone that started visibly from about the 9 O’clock position at 4.2” and ran to the 7-8 O’clock position at 7.1” for a total fracture length of ~2.9”. The widest separation of the burst zone fractures was just under 1” and was located at ~5.8”, near the mid-point of the fracture length. The left photo in Figure 2 shows a yellow arrow to indicate an apparent circumferential ring bulge centered at ~4.9”, located within the upstream end of the burst zone.

Figure 2. Photos of the lower barrel burst zone (yellow brackets) and ring bulge (yellow arrow) as seen from different angles with half-inch markings applied to the barrels in red paint marker prior to any destructive testing or inspection (13131 SAS 2-105 and 13131 SAS 2-127).

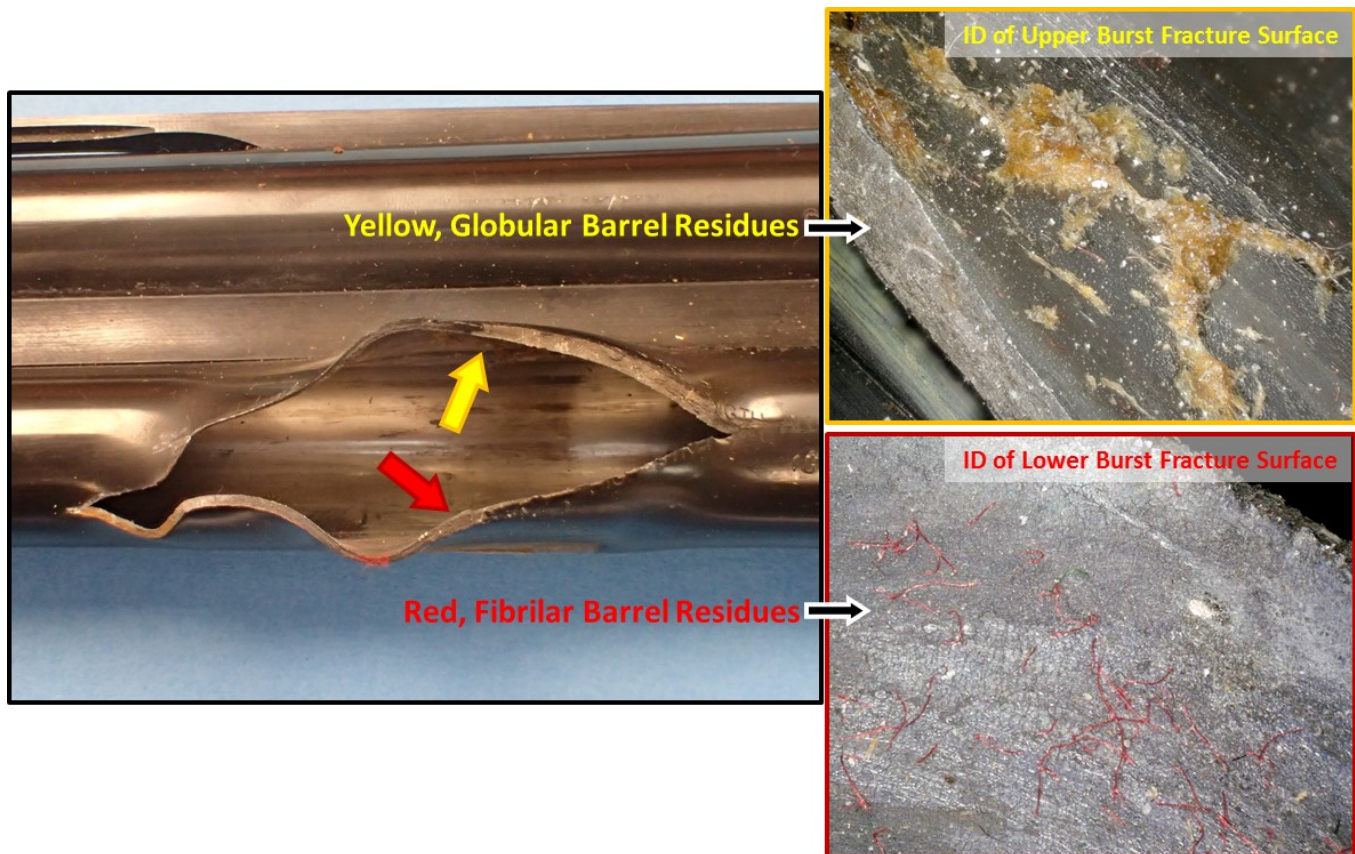
The left photo in Figure 3 shows a direct view of the barrel burst zone with a yellow arrow to indicate the location of visible, adhered barrel residues just inside the upper fracture surface. These residues were described by Mr. Roster as appearing “organic” and consistent with vegetative matter from the incident site. To this writer’s eyes, and with the aid of a 10x jeweler’s loop, these residues appeared distinctly yellow, reflective, translucent, and with a globular morphology. The red arrow in the left photo of Figure 3 shows the location of a less obvious region of barrel residues that were red, translucent, and with a fibrillar morphology, just inside the lower fracture surface, which were only visible with magnification. Digital optical microscope images at low magnification are shown on the right side of Figure 3, with black arrows indicating their respective locations from the photo at left.

Figure 3. Photo of the lower barrel burst zone (at left, 13131 SAS 2-045) with colored arrows to indicate the location of two visibly different internal barrel residues that were imaged in the optical microscope before any destructive testing (at right). More detailed microscopy imagery of these residues is provided in the following two figures below.

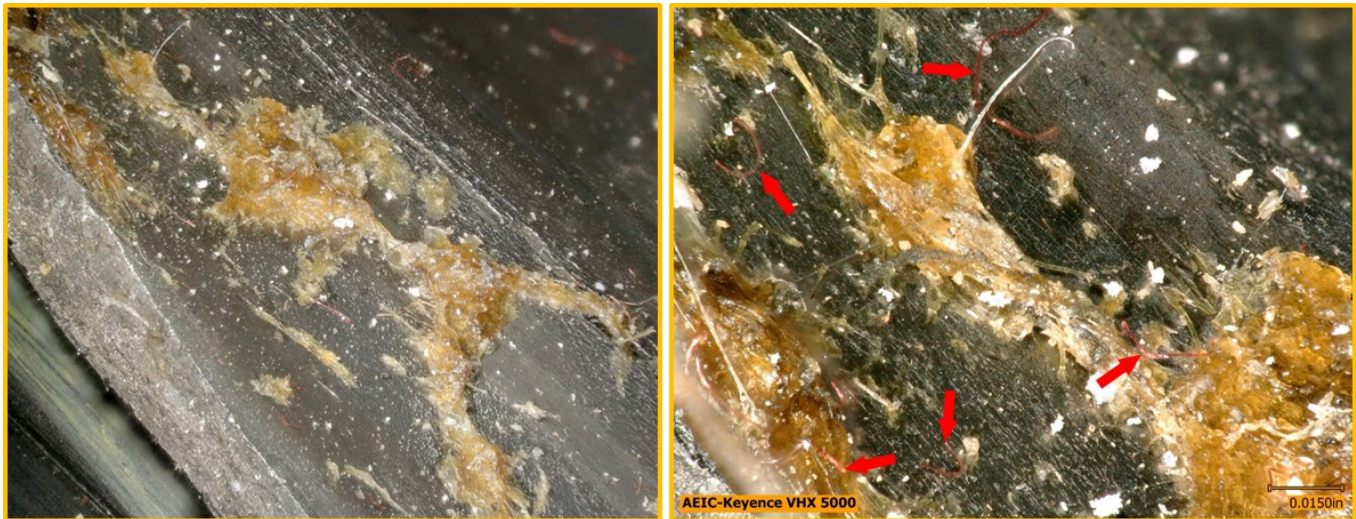
A set of higher magnification images of the yellow globular residues is provided in Figure 4 in which the distinctly yellow-colored, translucent character of the upper fracture ID residues is more obvious. With the naked eye, these yellow deposits did appear to have a matte or dispersive surface sheen, but with magnification and appropriate lighting, the shiny, reflective, yellow-coloration, and translucency, all became more evident. In the higher magnified view (Figure 4, right) the globular morphology is still apparent, but it is also combined with a dendritic morphology in which fibrillar extensions can be seen spanning the distances between globular deposits. There were also small brown particulate inclusions that could be seen in the translucent portions of the yellow residues, however, these were not readily captured in the images of Figure 4. The small red arrows in the right image of Figure 4 indicate the locations of less obvious red, translucent fibers that were dispersed intermittently, but uniformly around the yellow globular deposits.

Figure 4. Keyence digital optical microscopy images of the globular, barrel residue from just inside the upper burst zone fracture at low magnification (at left) and at high magnification (at right) showing the translucency of the globular and dendritic deposits looking like melted yellow plastic; the red arrows indicate the locations of individual, red translucent fibers like those found primarily on the lower burst zone fracture surface shown in the figure below.

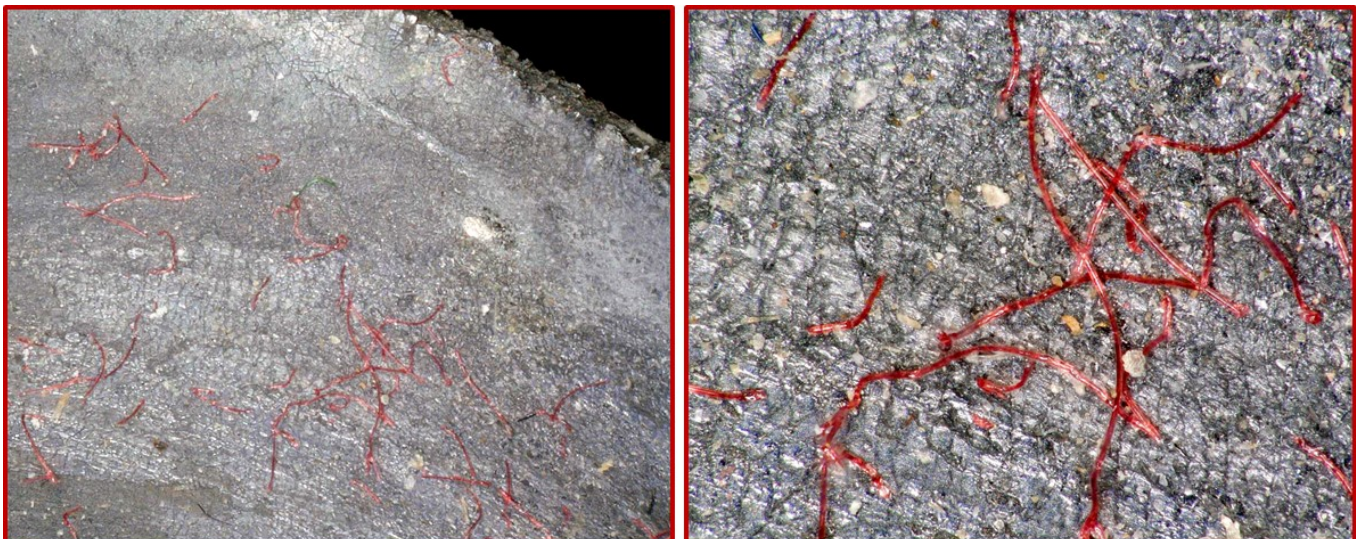
In contrast to the yellow-colored, globular deposits that appeared to be well adhered to the barrel ID surfaces, the dispersed, red-colored, fibers appeared to be only loosely attached and unmixed with the yellow deposits. Figure 5 shows the higher magnification microscopy images of the other barrel residue location, just inside the lower fracture surface where there appeared to be only the loosely adhered, red-colored, translucent fibers. Again, the higher magnification view at right shows the distinctly translucent and reflective character of the fibers as well as their irregular shapes/curvature and lengths.

Figure 5. Keyence digital optical microscopy images of the red, fibrillar, barrel residues from just inside the lower burst zone fracture at low magnification (at left) and at high magnification (at right) showing the translucency and fibrillar morphology of the deposits.

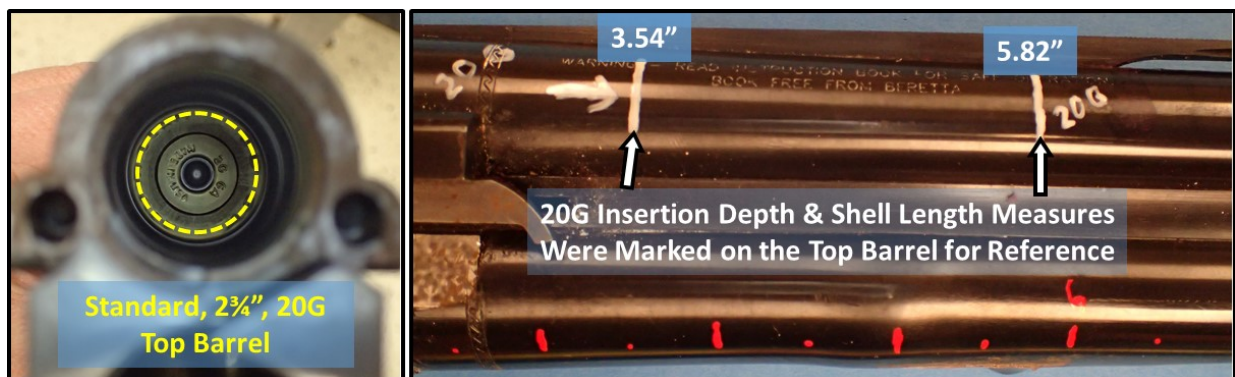
Figure 6. Photos showing the gravity insertion of a standard 2 $\frac{3}{4}$ " 20G shotshell where it came to rest in the forcing cone of the top barrel (yellow dashed circle at left) and the subsequent registration marks applied in white paint marker to indicate the depth and extent of the 20G shell (at right, white arrows; 13131 SAS 2-155 and 13131 SAS 2-167).

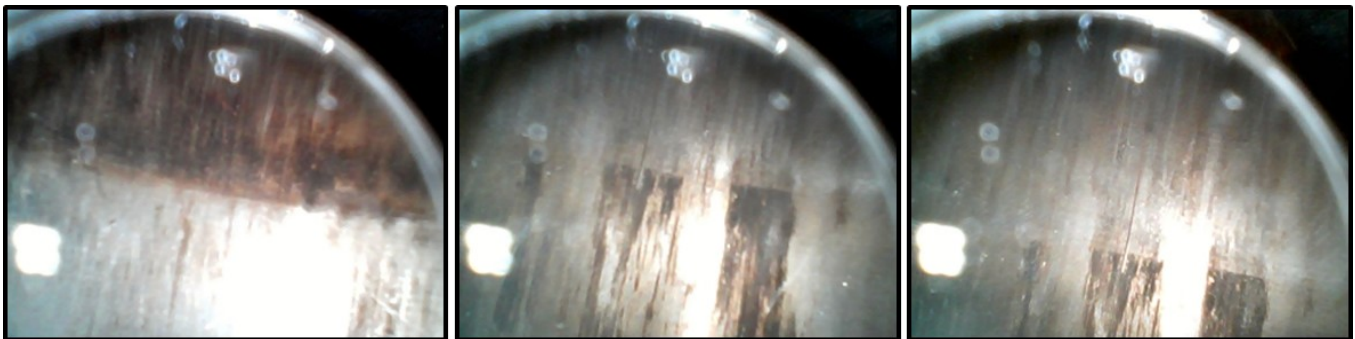
Figure 7. Borescope image captures using a sidewall viewing mirror from inside the lower barrel bore at ~3.5" (left image) and ~4.0" (middle and right images) from the breech end that show distinct circumferential deposits, color streaks/bands and circumferential and longitudinal scratches just upstream of the burst zone.

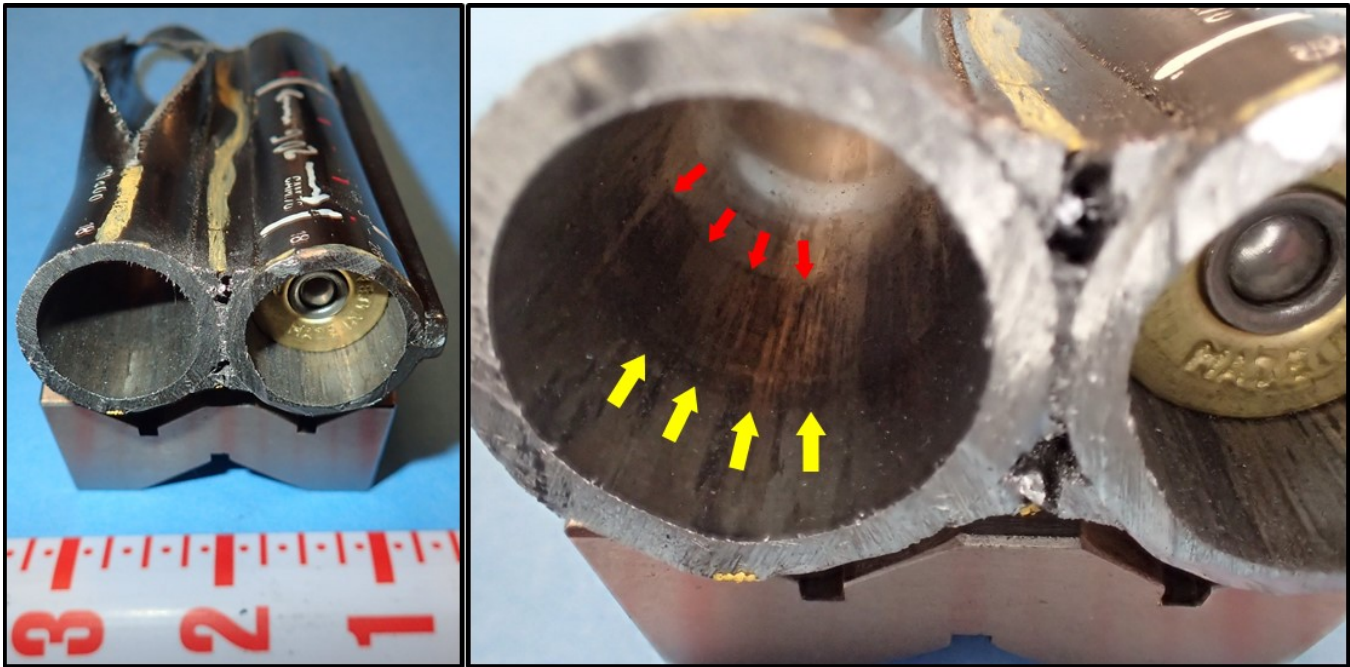
Figure 10 shows photos of the barrel section after making the first two transverse cuts across both barrels, but before subsequent cuts (as viewed from the upstream or breech-ward end of the section). This examination was done in order to re-confirm the prior gauged depth and length position of a gravity-lodged 20G, 2¾“ shell in the top barrel tube as seen on the right side of both photos in Figure 10. Closer inspection of the lower barrel tube, just upstream of the burst zone also confirmed the distinct barrel residue coloration bands and scratches as seen in the right photo of Figure 10 in the location of the yellow and red arrows. Note the apparent similarities of depth between the 20G shell in the upper barrel tube and the color banding in the lower barrel tube at the location of the yellow arrows.

Figure 10. Before sectioning was complete, the insertion of a 20G shell was reconfirmed in the top barrel as shown in the photo at left, and even at this stage, physical banding, streaking, scratching, and discolorations were visible and appeared to correspond closely to the location of the 20G metal head lip (yellow arrows); additional circumferential bands could be seen in several locations downstream of this depth (red arrows; 13131 SAS 2-314 and 13131 SAS 2-320).

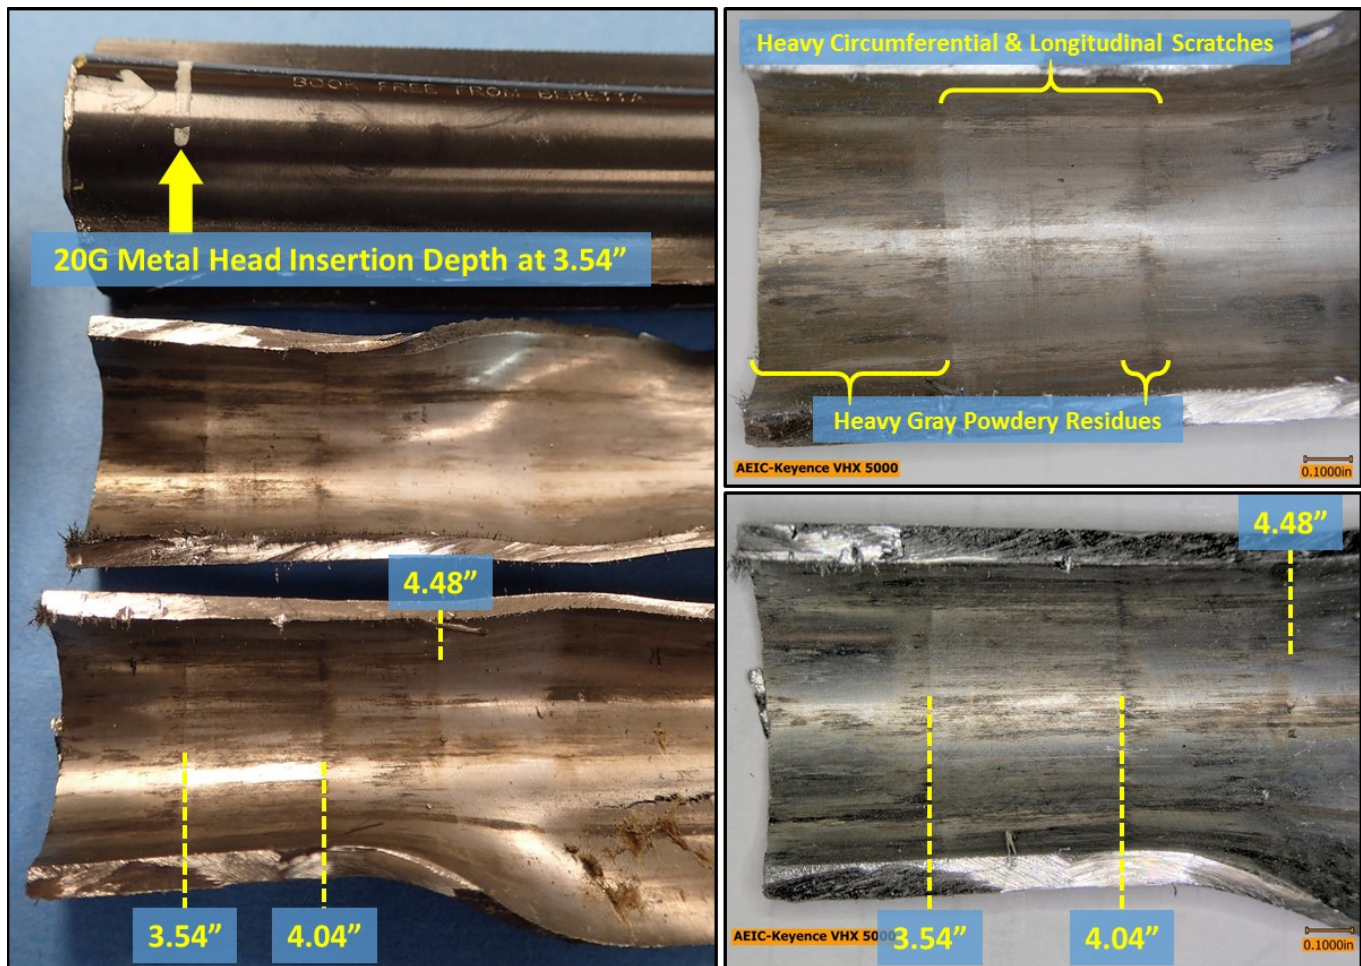
Figure 11. Photo of the fully sectioned and opened lower barrel in the region of interest (at left; 13131 SAS 2-349), which revealed visible bands/streaks of powdery, grey/brown deposits just upstream of the burst zone and ring bulge; similar Keyence microscope images are shown at right with the yellow dashed registration markings based on the distance from the breech end (please note the identical distance measured for the 20G shell insertion depth at the yellow arrow and the most upstream circumferential band at 3.54").

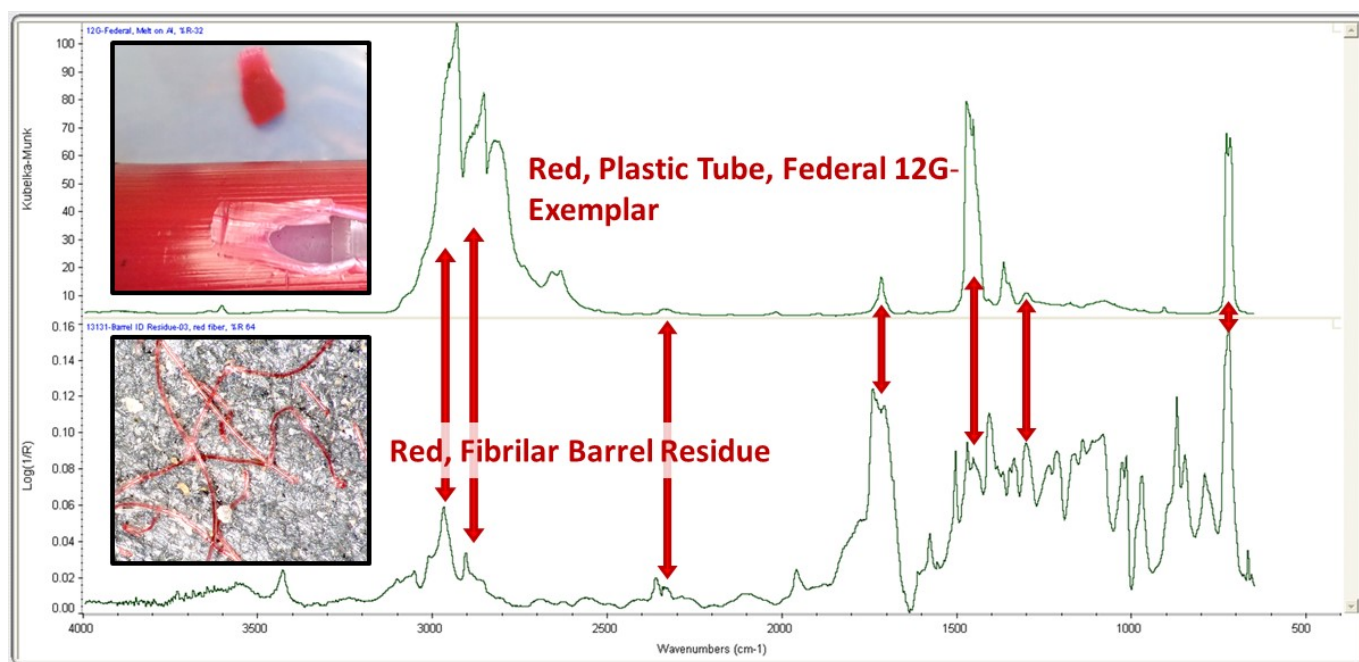
Figure 12. Reflected light microscope infrared absorbance spectra of the exterior surface of the red plastic tube material from an exemplar Federal 12G shotshell (top data trace) compared with the similarly obtained absorbance spectra of the red, fibrillar barrel residues (bottom data trace); the red arrows indicate similar spectral features.

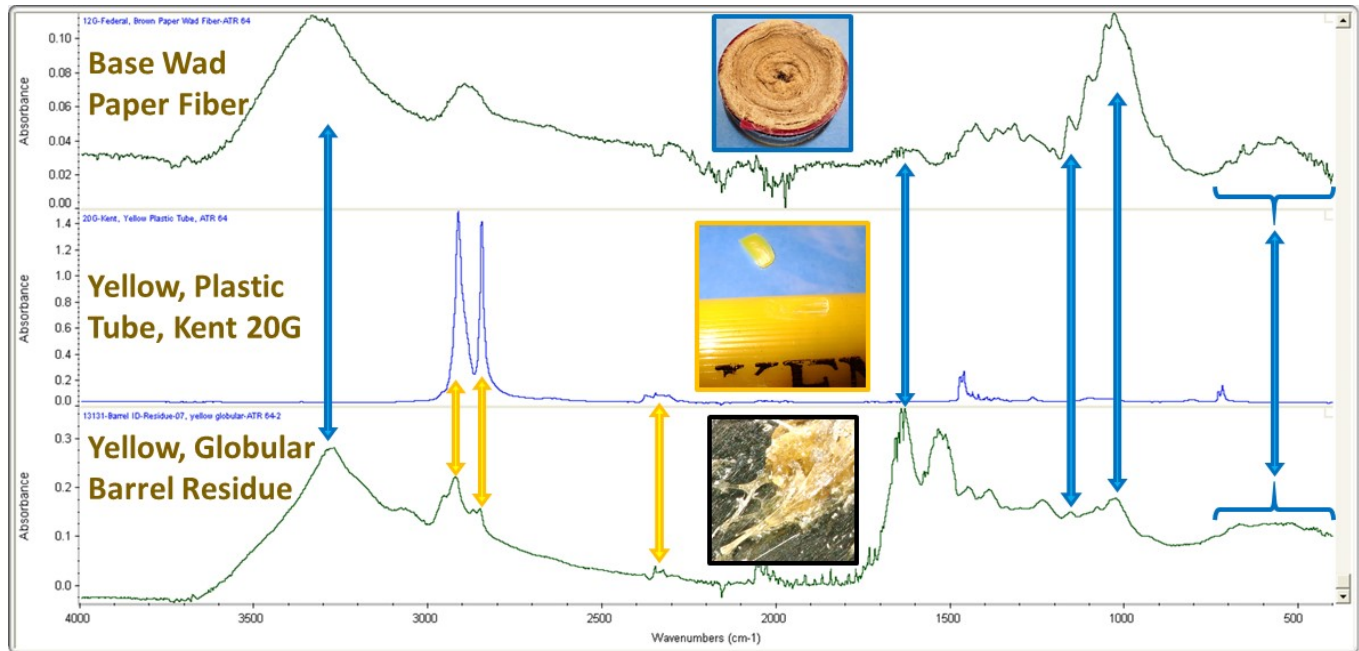
Similarly, the yellow globular residues were analyzed in the ATR-FTIR cell and the infrared absorbance spectra is shown in the bottom data trace of Figure 13. Again this spectrum was complex, but had a number of distinctive broad absorbances that were similar to the ATR-FTIR spectrum of base wad paper fibers, shown in the top data trace of Figure 13 with blue arrows indicating spectral similarities. There were also three distinct absorbances (yellow arrows) that corresponded to the ATR-FTIR spectrum of the yellow

Figure 13. ATR-FTIR absorbance spectra of: the yellow globular barrel residue (bottom data trace), the exterior surface of the yellow plastic tube material from a Kent 20G shotshell (middle data trace), and the paper fibers from the base wad of a Federal 12G exemplar shotshell (top data trace); the blue and yellow arrows indicate similar spectral features.

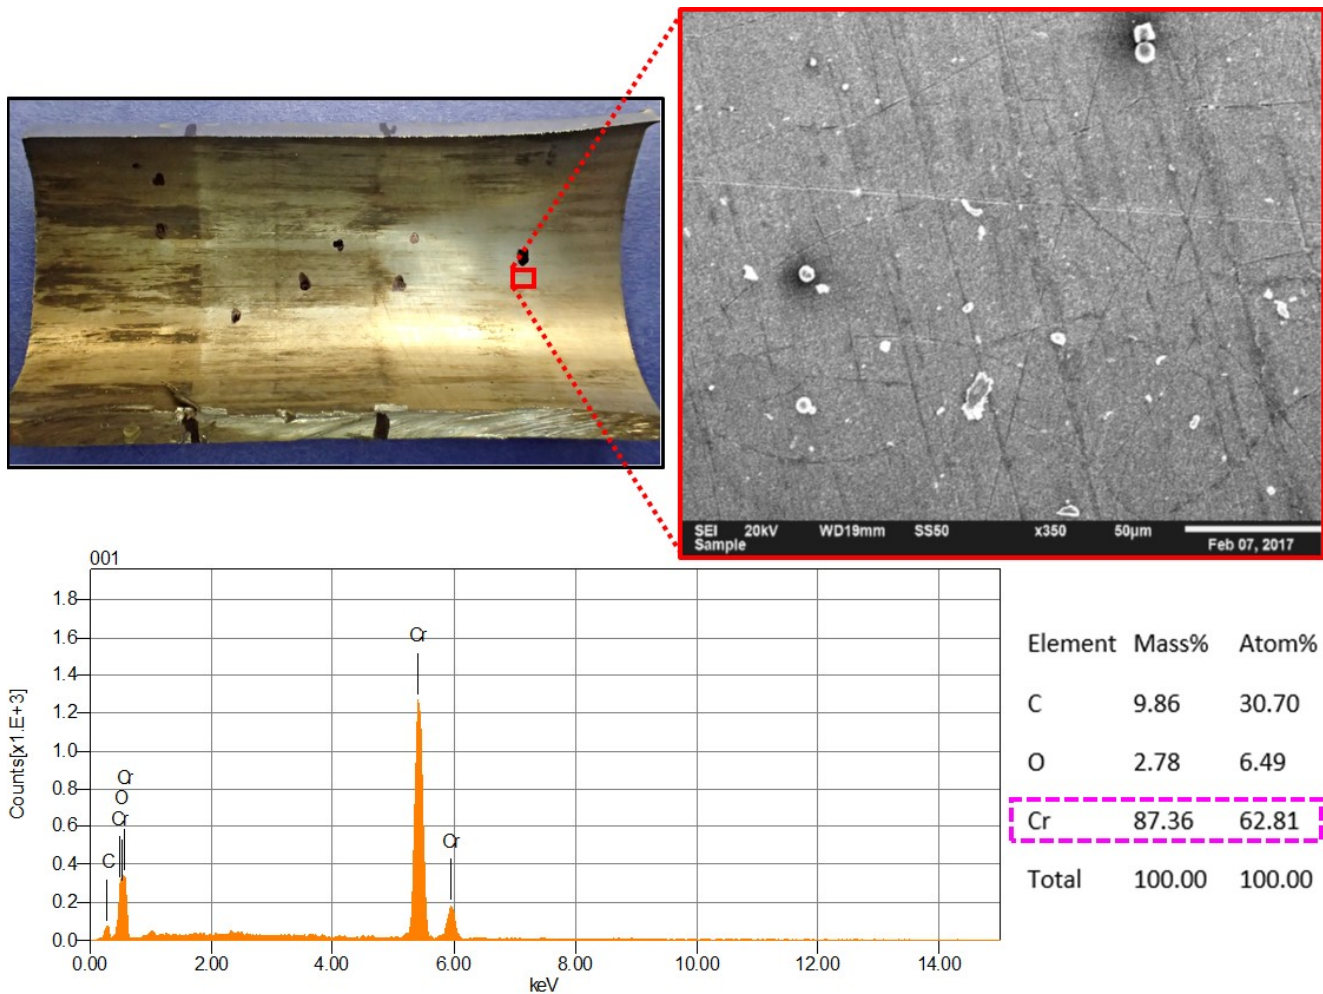
Figure 17. Index photo of the lower barrel section (top left, 13131 SAS 3-038) with the inset red rectangle corresponding to the SEM image location at top right that showed a relatively clean area of barrel ID surface where the EDS data (EDS 001) confirmed chromium as the only heavy element present (Cr, pink dashed rectangle).

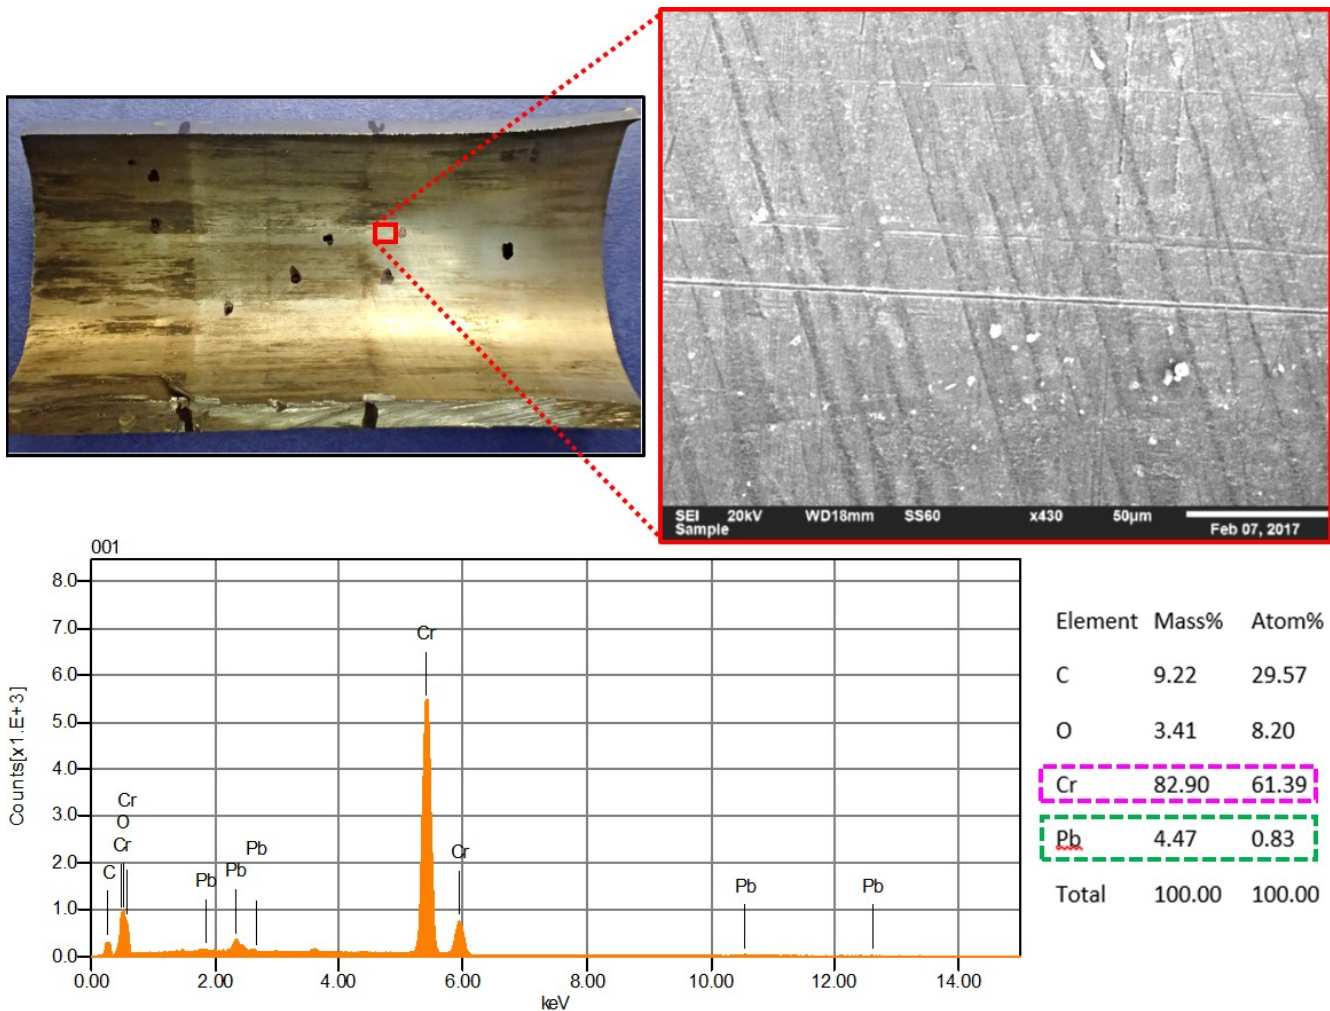
Figure 18. Index photo of the lower barrel section (top left, 13131 SAS 3-038) with the inset red rectangle corresponding to the SEM image location at top right that showed an area of barrel ID surface with light residues, but heavy scratching; the EDS data (EDS 002) confirmed predominantly chromium (Cr, pink dashed rectangle) with just under 5% lead present (Pb, green dashed rectangle).

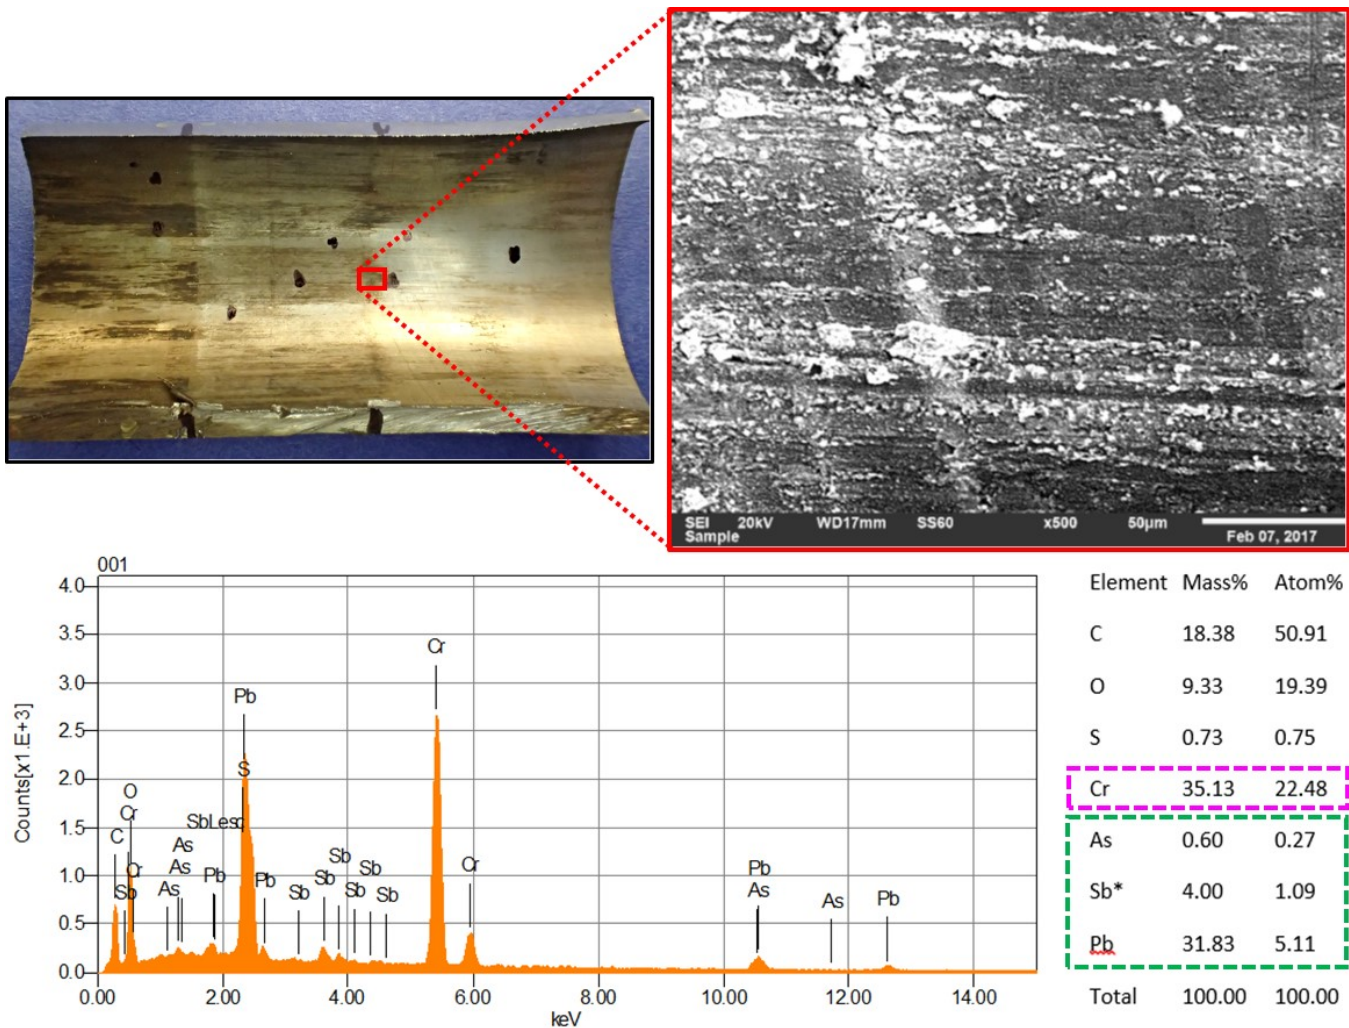
Figure 19. Index photo of the lower barrel section (top left, 13131 SAS 3-038) with the inset red rectangle corresponding to the SEM image location at top right that shows a high magnification image centered on the darkly-colored circumferential band at 4.04" with visible, heavy, gray powdery residue and longitudinal deposit streaking; the EDS data (EDS 003) identified less chromium (Cr 35%, pink dashed rectangle) from the barrel surface, but significantly more lead (32%) accompanied by antimony and trace arsenic (Pb, Sb, As, green dashed rectangle).

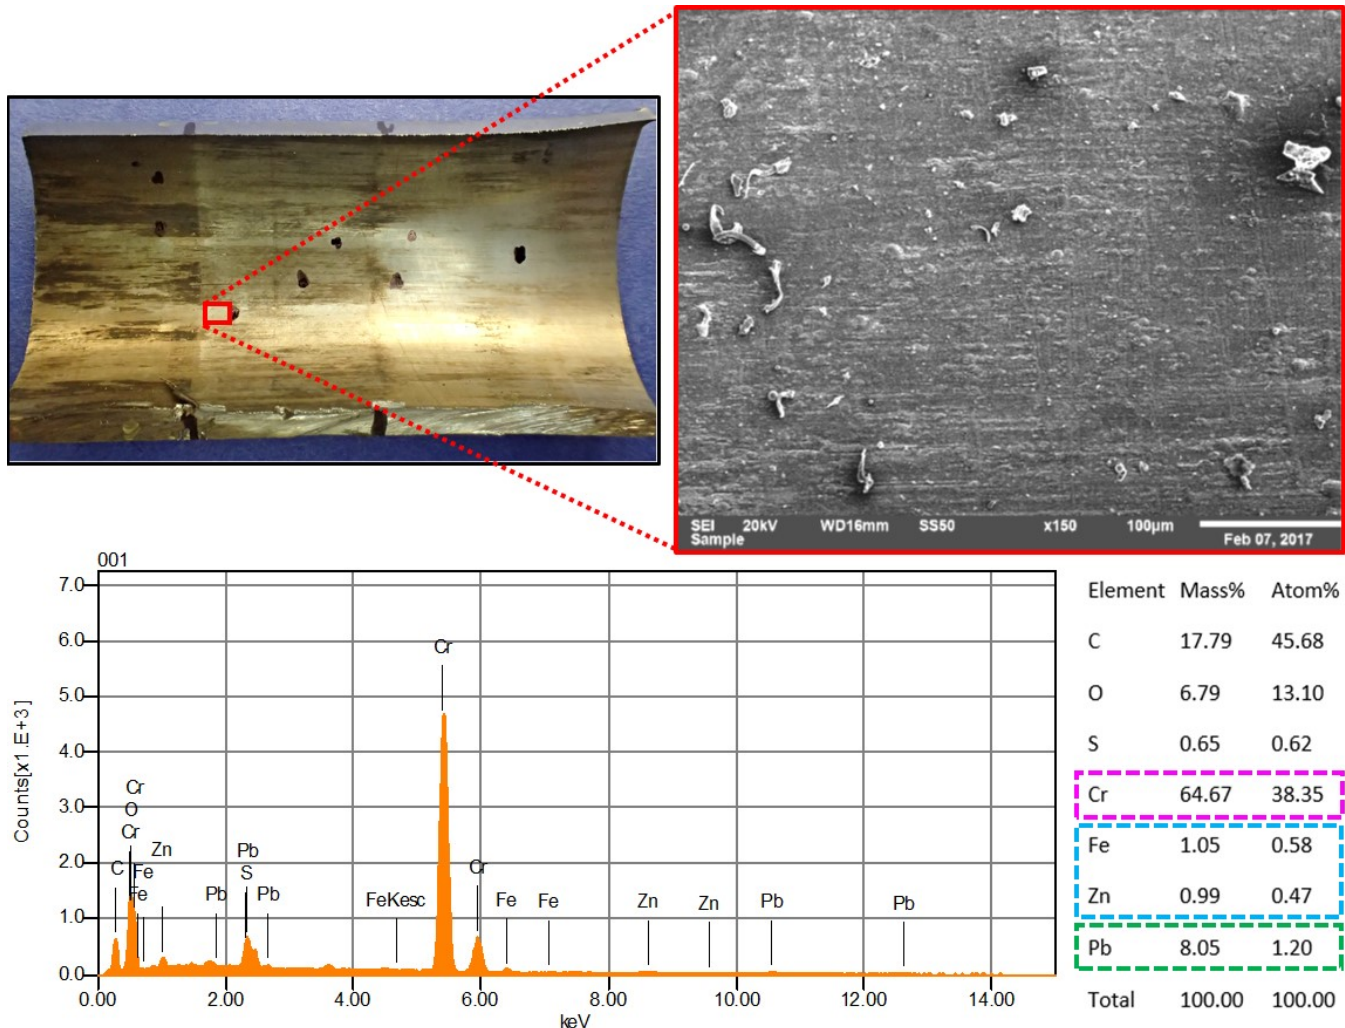
Figure 20. Index photo of the lower barrel section (top left, 13131 SAS 3-038) with the inset red rectangle corresponding to the SEM image location at top right that shows the area of the barrel surface just downstream of the darkly-colored circumferential band at 3.54" that registered with the exact location where a 20G head would hang-up within the forcing cone of the barrel; the EDS data (EDS 006) identified predominantly chromium and lead (Cr 65%, Pb 8%, pink and green dashed rectangle, respectively), but also identified iron and zinc, both at ~1% (Fe, Zn, blue dashed rectangle).

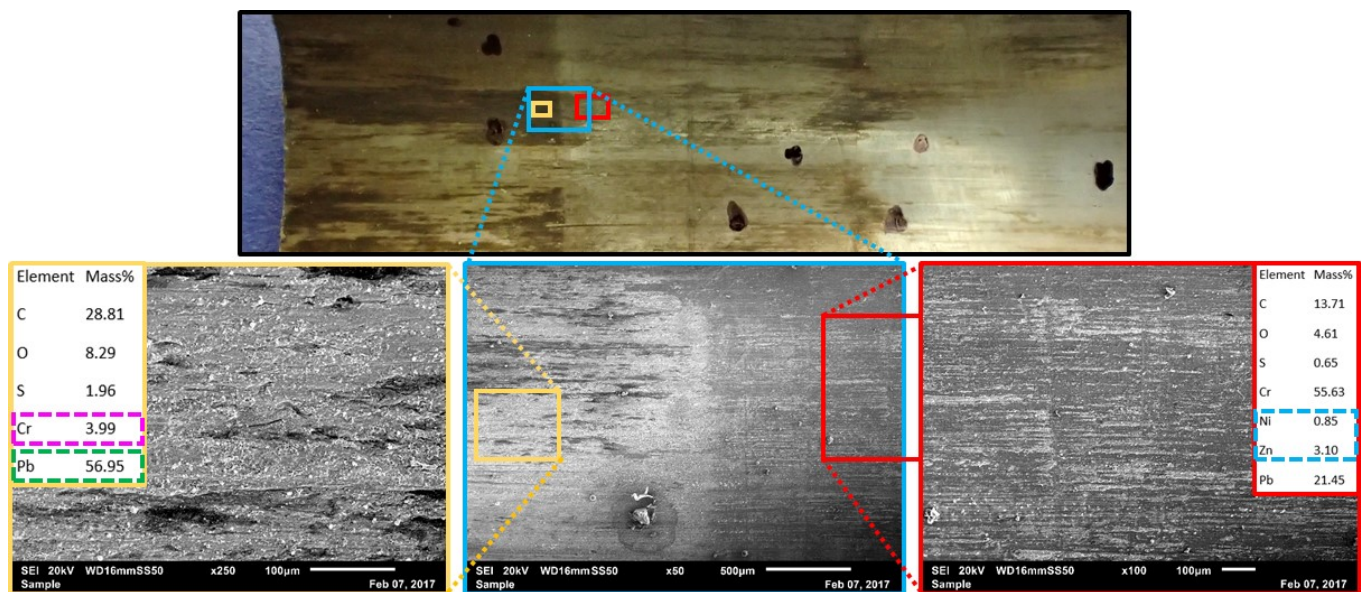
at 100x magnification. Describing this figure another way would be that the middle SEM shows the areas on either side of the 3.54" position with the left SEM showing the surface upstream of 3.54" and the right SEM showing the surface downstream of 3.54". Obviously, these two surface regions are very different in appearance with the upstream region exhibiting extremely heavy lead deposits at 57% with only 4% chromium showing through the lead residues (see bottom left SEM with EDS inset table). The downstream region by contrast looks scraped or sheared in the longitudinal direction with 56% of the chromium wall showing through the banded deposits identified as 21% lead, 3% zinc, and just under 1% nickel (see bottom right SEM with EDS inset table). It is unexpected to again find zinc along with nickel, but the identification of first, zinc with iron (in Figure 20 above) and second, zinc with nickel (in Figure 21 below) only occurred in the light colored band just downstream of 3.54".

Figure 21. Magnified index photo of the lower barrel section (top middle, 13131 SAS 3-038) with the inset colored rectangles corresponding to the SEM images in the bottom row. The lower middle SEM image (blue frame) shows a 50x magnified view of the two barrel surface zones on either side of the 3.54" circumferential band. The lower left SEM image (gold frame) shows a 250x view of the barrel surface just upstream of 3.54" with the inset EDS data identifying 57% lead and only 4% chromium at this location (EDS 007B). The lower right SEM image (red frame) shows a 100x view of the barrel surface just downstream of 3.54" with the inset EDS data identifying 56% chromium, 21% lead, 3% zinc, and 0.85% nickel (EDS 007A).

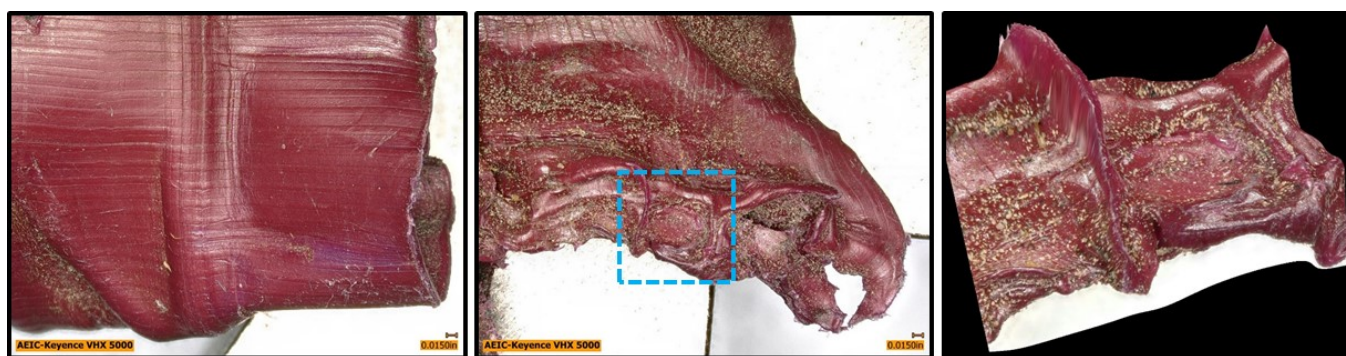
In Mr. Roster's ammunition report (dated "11-20-2016"; also marked JSB000341-378) he attributed the roughly damaged portion of the "separated hull" artifact that was at the opposite end from the crimp end (see the lower right photo of Figure 24) as having possibly come from the impact of #6 shot pellets. Mr. Roster further claimed that what he termed an "indent", "dimple", or "pit" located at the position in the blue dashed rectangle of Figure 24 was perfectly sized and cupped to fit a #6 shot pellet. During this writer's examination of the "separated hull" artifact, an optical 3D profile was prepared from high-resolution Z-stacking images in the Keyence VHX-5000 microscope, and the rightmost image shows a rotated 3D reconstruction of the artifact "dimple". Given the undocumented nature of where and when this artifact was recovered, there are too many possibilities for this writer to consider on how this artifact could have lost its metal head, become kinked, damaged, deformed, and wrinkled.

Figure 24. Keyence digital microscopy images of the separated hull artifact viewing magnified views of the crimp end (left), the separated head end (middle) with a highlight of the feature that Mr. Roster attributed to a shot impression (blue dashed rectangle), and the 3D projection of this region (right).

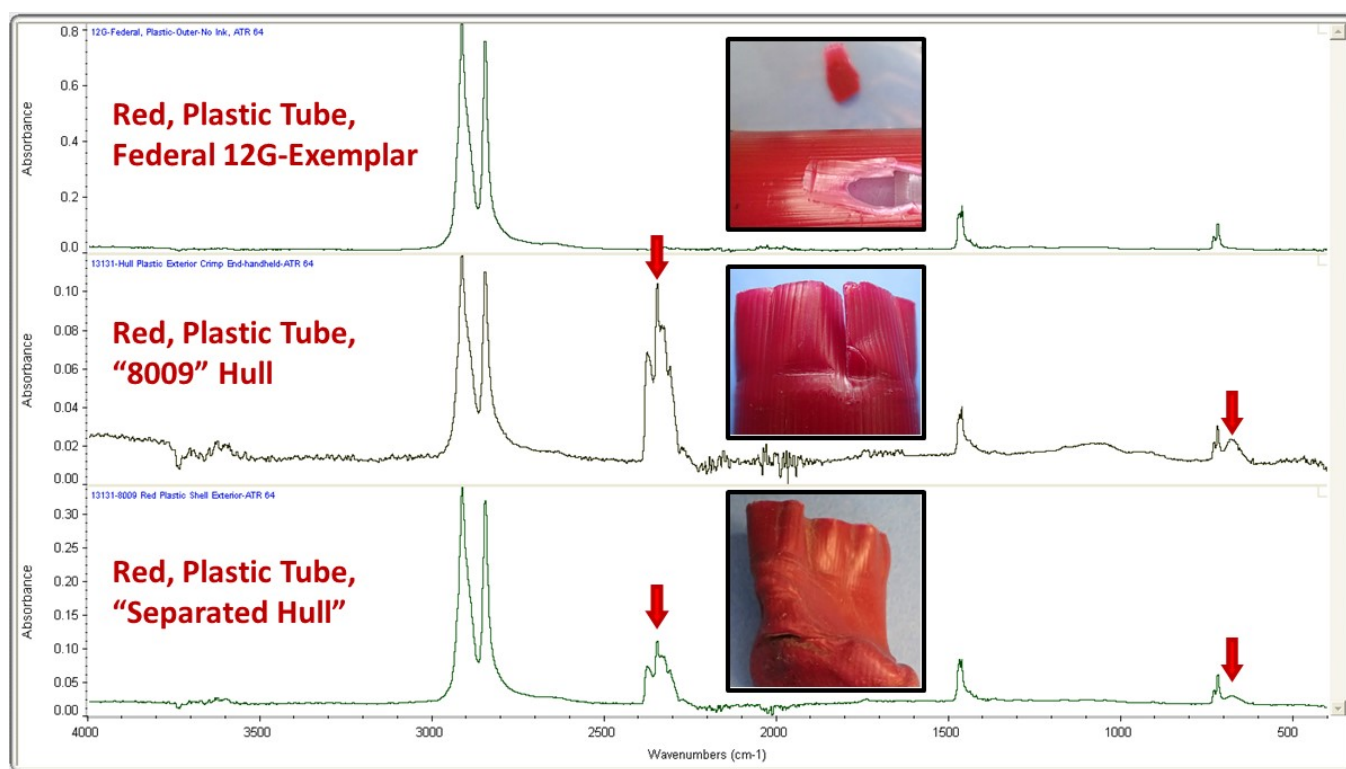
Figure 25. ATR-FTIR absorbance spectra of: the exterior red plastic tube material from a Federal 12G exemplar (top data trace), the exterior red plastic tube material from the “8009 spent hull” (middle data trace), and the exterior red plastic tube material from the “separated hull” (bottom data trace); the red arrows indicate unidentified absorbance signals that differed from the exemplar spectrum.

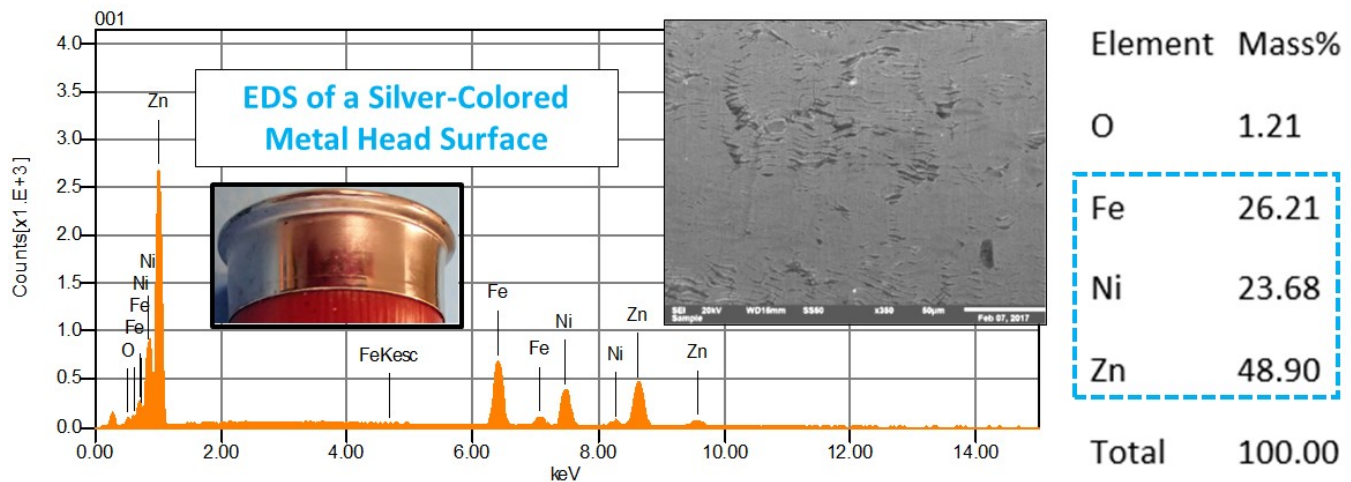
The EDS data in Figure 25 is provided as an example of a “silver-colored” metal head material that is common in many types of shotshell rounds (.410, 20G, 12G, 10G, etc.) where solid brass (copper and zinc) has been replaced with steel coated with an anti-corrosion coating that typically contains significant quantities of zinc, iron, and nickel, a composition often used to “brighten” galvanized steel. Because of the expense of copper, more and more ammunition manufacturers use steel instead of brass. Throughout the SEM/EDS testing, only two locations were found that showed deposits of zinc and iron or nickel (see Figures 20 and 21 above), and that was just downstream of 3.54” and exactly where the deposits of a 20G obstruction would leave deposits of its metal head material on the bore of the subject barrel. Since there were no locations where copper was identified on the bore surface, it is likely that the obstructing 20G shotshell possessed a brightened galvanized steel head that was composed of zinc, iron, and nickel.

Figure 25. EDS data obtained on the exterior surface of a Federal, silver-colored metal head identifying zinc, nickel, and iron (Zn, Ni, Fe, blue dashed rectangle) with inset photo and SEM image.
